SERVICE BULLETIN	
Service Bulletin #	JSA-008
Superseded Bulletin #	
Issue Date	12/01/2011
Effective Date	12/01/2011
Limitations for Completion	At Next 100 hour or Annual Service
Make & Model Affected	J170-SP Serial # 75 thru # 207
Page 1 of 2

SERVICE BULLETIN: **JSB 029-1**

Subject: **J170 Handling Upgrade**

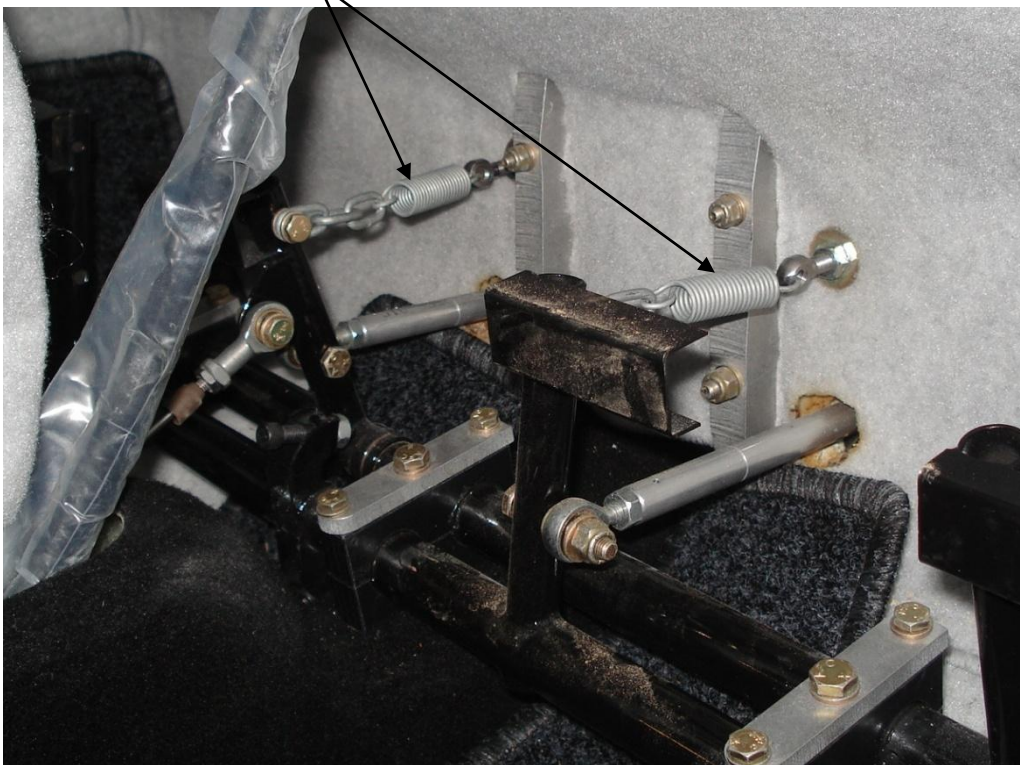
Figure 1 – Original Rudder Centring Springs

Rudder centring spring & chain assemblies – remove.

- Remove the existing rudder springs and chains from the rudder pedals.
- Fit the new spring mounting bracket to the aircraft's centre console using 6 off TLR rivets as shown in Figure 2. The exact position is not critical – but it should be aligned with the front of the rudder cable mount and positioned so that the chains and springs run as straight as possible.

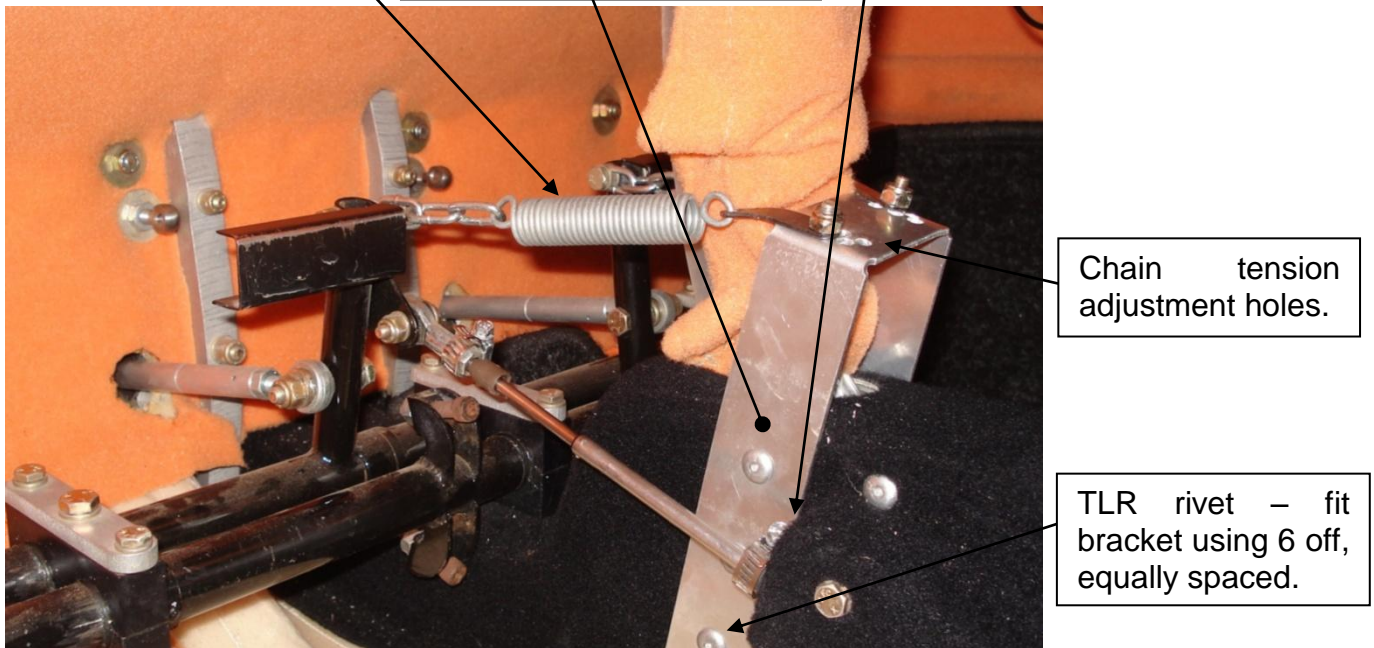
Figure 2 – New Rudder Centring Springs

New rudder centring spring & chain assembly

Spring anchoring bracket – rivet to centre console

Align rear of bracket to front of rudder cable mount

- Fit the new springs as shown in Figure 2. Adjustment of these springs is important for correct handling of the aircraft. The springs must be set so that when the rudder pedals are centered neither spring is carrying any load – but as soon as the pedals move slightly a spring takes up tension. If the springs are set too tight – i.e. when the pedals are centered both springs are carrying some tension – this will reduce the centring effect of the spring system and must be avoided. If the springs are set too loose the pedals must move too far before there is any centring effect – this makes the system ineffective near centre and must also be avoided.

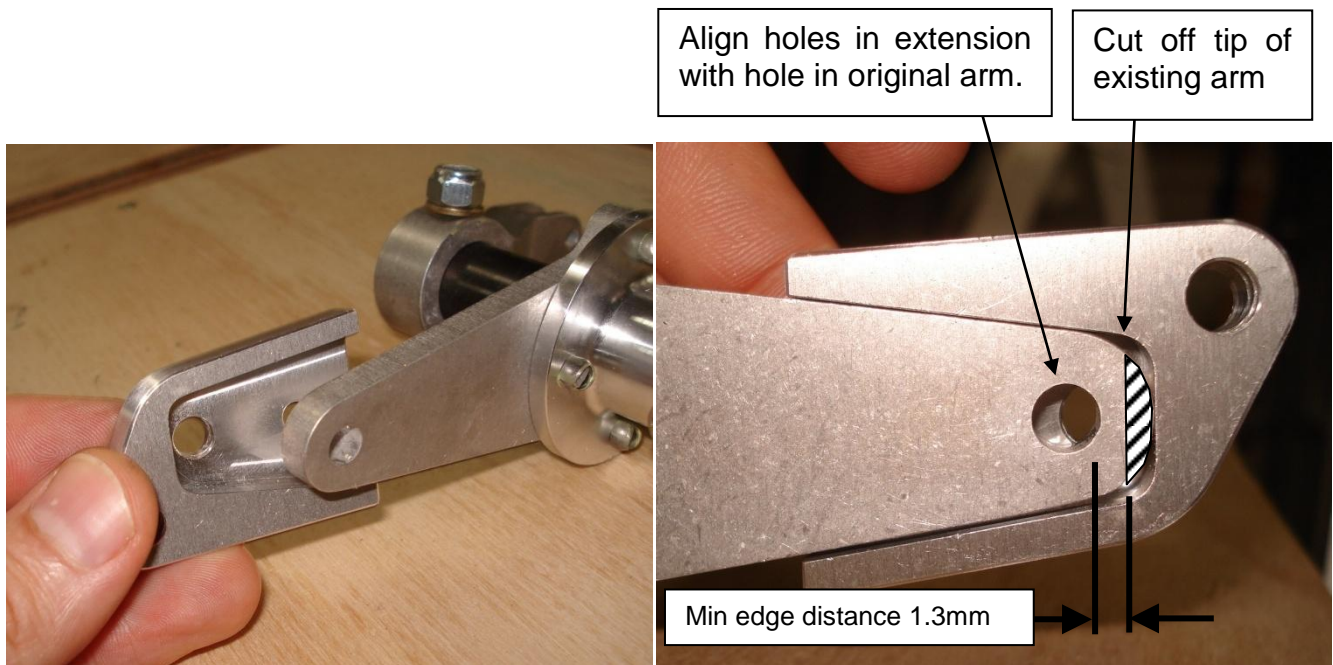
Figure 3 – Fitting Adaptor to Drive Arm

Use the 3/16" hole in the adaptor as a guide to drill a matching hole in the existing arm

- Apply the new drive adaptor to the existing internal flap drive arm from the outboard side – it will be obvious how much material must be removed from the existing arm to fit the adaptor. Figure 3 (right) shows this. Carefully remove this material, removing just enough so that the extension slides onto the arm far enough to align the bolt holes and to fit snugly around the arm. De-burr the tip. Note the minimum edge distance shown in Figure 3 (right).

- The adaptor can now be placed on the inboard side of the flap drive arm and used as a guide to drill the new 3/16” hole. Carefully drill through the hole on the adaptor and through the existing drive arm.

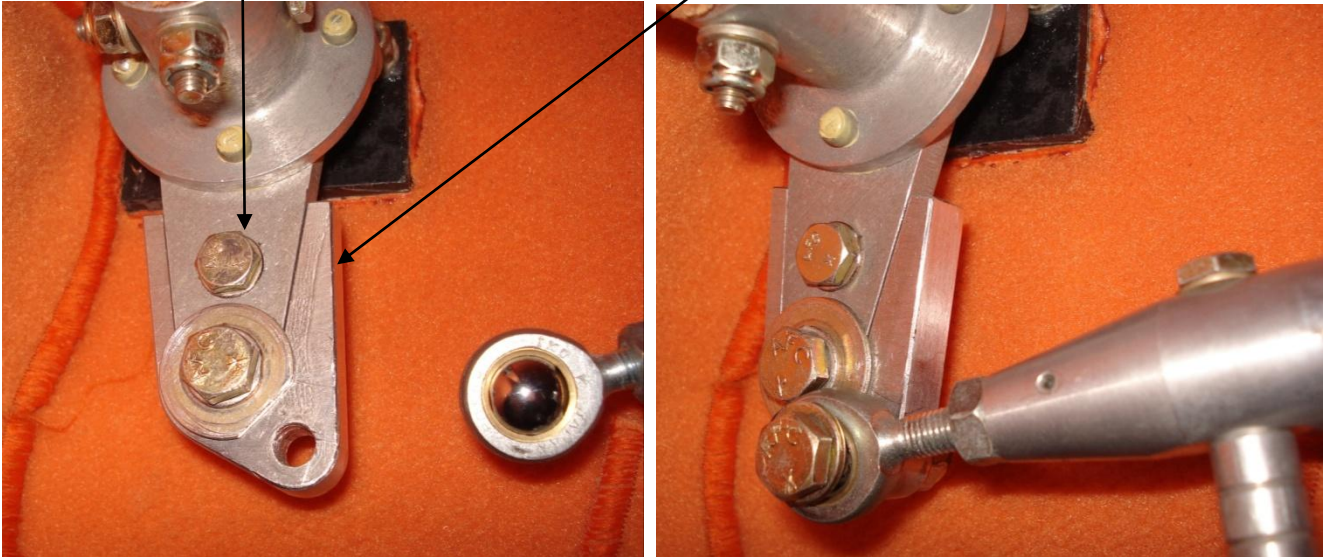
Figure 4 – Adaptor in Place

Adaptor bolted & bonded in place. Use of penny washer is optional.

- Remove the adaptor from the drive arm. Clean it using Acetone. Mix and apply 5-minute epoxy resin to its socket.
- Bolt the adaptor to the arm using 1 off ¼” and 1 off 3/16” bolts, orienting it as shown in Figure 4. Wipe off any excess resin. Both bolts can be fitted from the cabin side of the drive arm – care will be needed to use the correct length bolt so that the tails of the bolts do
